SUSQUEHANNA RIVER BASIN
BURGOON RUN, BLAIR COUNTY

UPPER KITTANNING DAM

NDI I.D. NO: 530

PHASE I INSPECTION REPORT

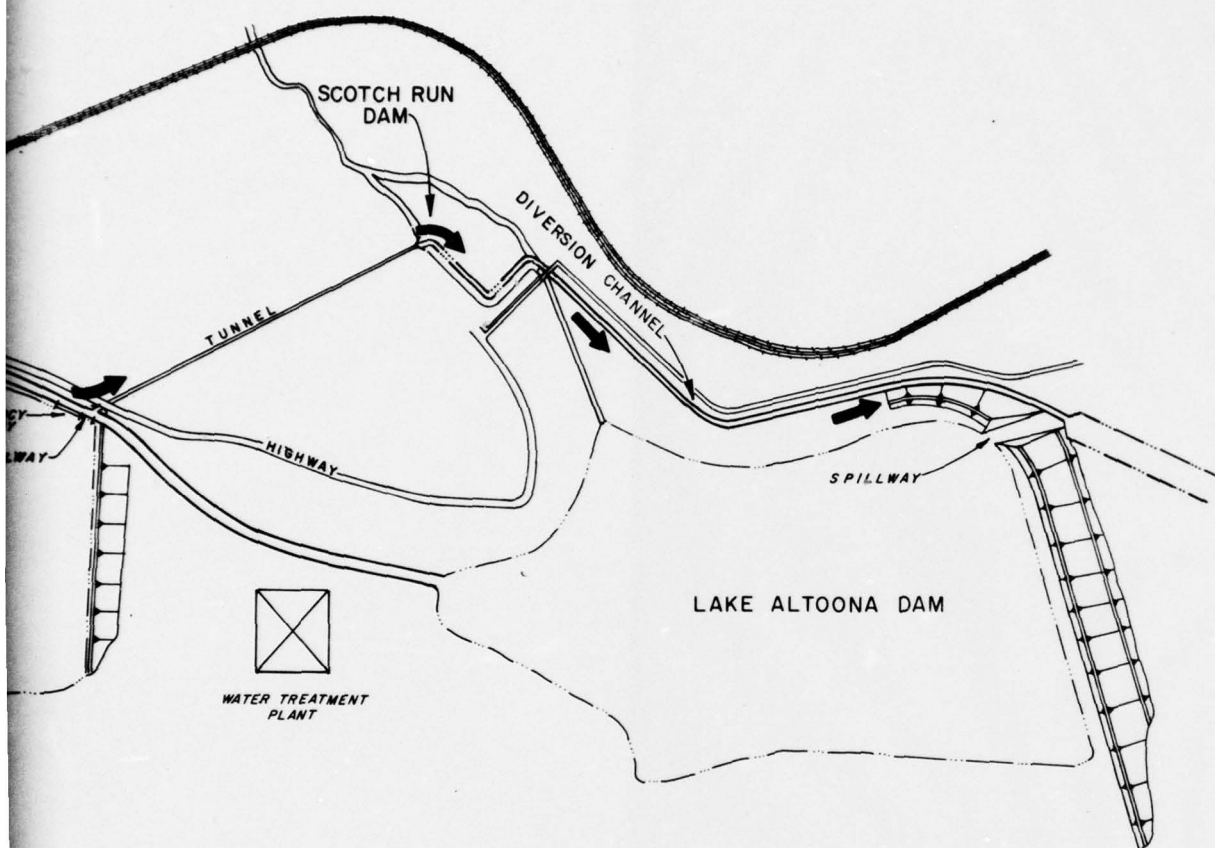
PLATE 2
UPPER KITTANNING DAM
DIVERSION CHANNEL PLAN
D'APPOLONIA

Under normal flow conditions, runoff from the watershed bypasses the reservoir. However, with increasing flow in the diversion channel, the reservoir would start to receive uncontrolled inflow through the diversion channel overflow section (Plate 2). This overflow section is located on the dike which separates the diversion channel and the reservoir. It is a 98-foot-long broad-crested section with its crest at a level about four feet four inches above the bottom of the diversion channel. Therefore, in the event of flow depths over four feet four inches in the diversion channel, the reservoir would receive uncontrolled inflow.

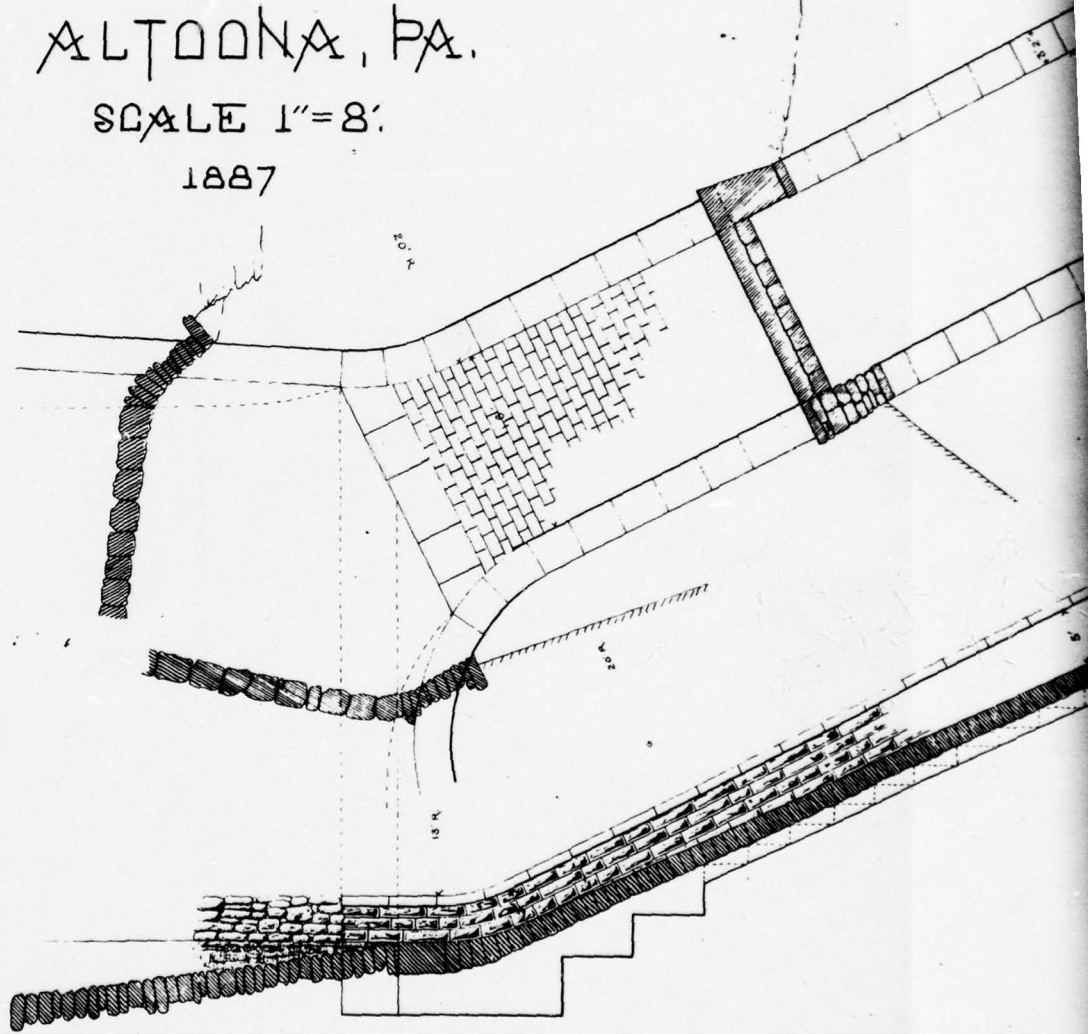
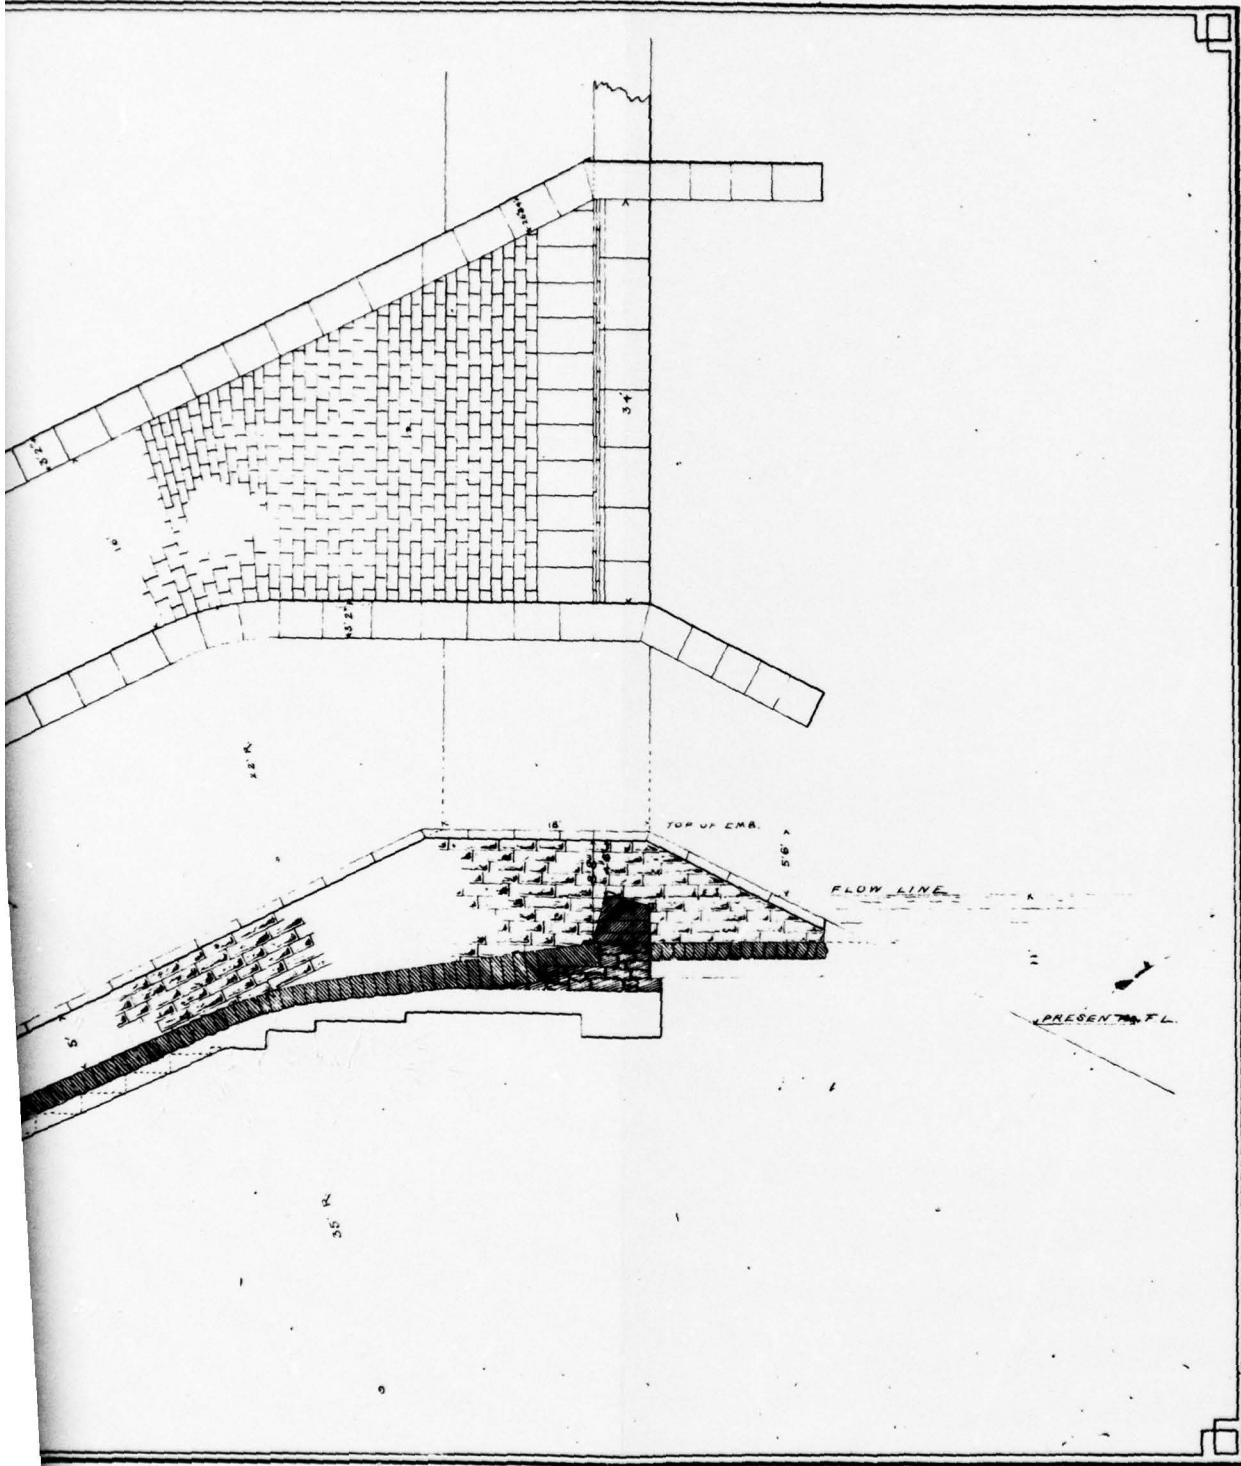
PLATE 3
D'APPOLONIA

2.2 Construction. Very limited information is available on the construction of the dam. Reference to a "present flow line" in a drawing dated 1887 (Plate 3) suggests that the dam was built prior to 1887. A drawing dated 1889 (Plate 5) also refers to an "old stone filling" and to an "old spillway." This drawing also indicates that the dam was enlarged in 1889.

d. Post-Construction Changes. As discussed in Section 2.2, the dam was enlarged in 1894. Plates 3 and 5 illustrate this post-construction change.
